## Analysis of the end-of-life the front suspension beam of a vehicle

Sławomir Kowalski<sup>a</sup>, Kazimierz Opoka<sup>a</sup>, Józef Ciuła<sup>a</sup>

<sup>a</sup>State University of Applied Sciences in Nowy Sącz, ul. Zamenhofska 1a, 33-300 Nowy Sącz, Poland

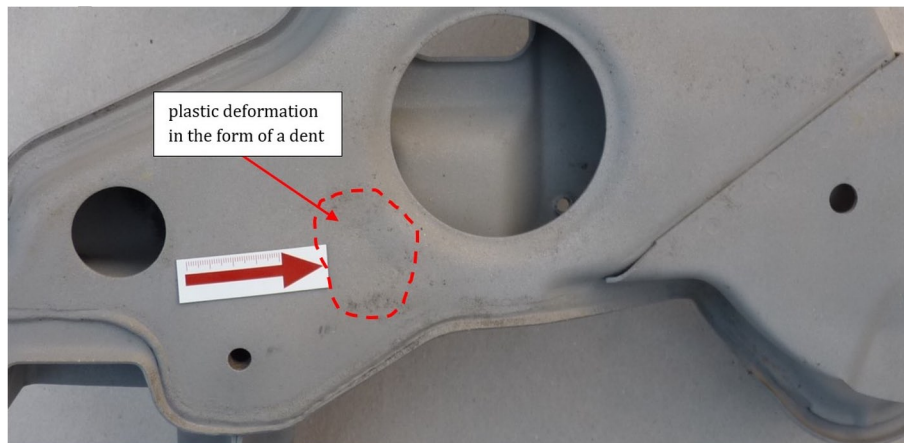
The macrographic observations of the beam plating demonstrated wear in the form of plastic deformations of a peculiar arched shape (Fig. 4). The range of those deformations was insignificant and had no influence on the change of the original beam shape. Linear scratches of the plating as well as hairline cracks of the minimum depth in the beam plating were also noted. The cause of that kind of damage is sought in the contact of that element of the chassis with items making the road dirty, such as sand particles, stones etc., which may have fallen down from aggregate-carrying vehicles. Such items may have also been brought onto the road by vehicles joining the traffic from a construction area or aggregate collection points. Damage described above was located at the lower beam plating, where friction or impact contact with obstacles present on the road may take place.

Fig. 4. Beam damage in the form of plastic deformation

That damage, consisting in plastic deformations, did not affect driving safety and was easy to locate during technical inspections, that is why a detailed analysis of that damage is omitted in the further part of this article. The main focus was on the wear following from the natural operation process, which cannot be verified and removed during diagnostic tests.

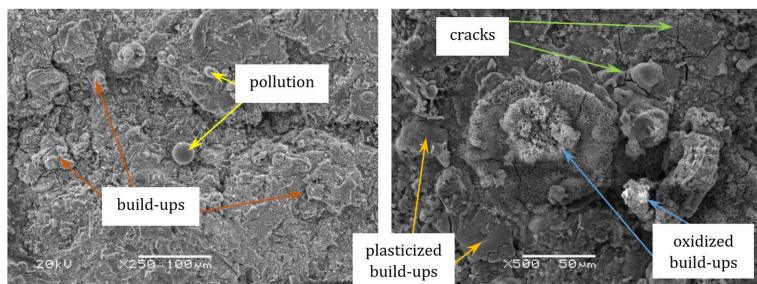
In order to recognise features of the wear zones, microscopic observations were conducted. Fig. 6 presents SEM images of wear traces.

The microscopic observations confirmed the macroscopic observations suggesting that the main damage of the beam at the point of mounting the stabilisers rod is constituted by corrosion or fretting wear. The following features were observed: fatigue crack, corrosion pits, hairline cracks and material build-ups, which become plasticised and crumbled.

Fig. 6. Sample SEM images of the wear products on the front suspension beam surface

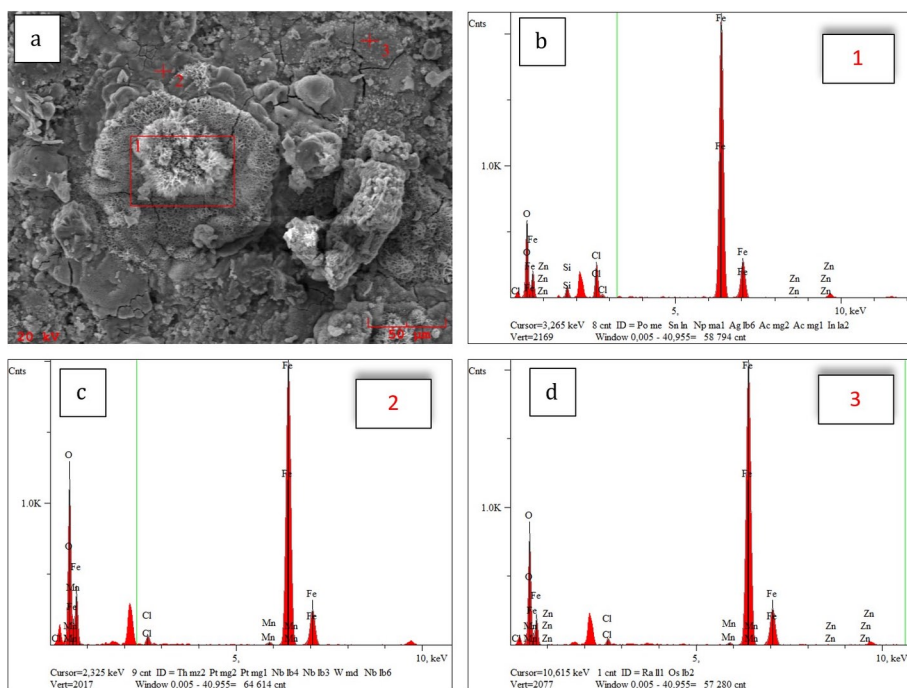
Fig. 8. Spot analysis of the chemical composition: a) SEM image, b) radiation spectrum peculiar for point 1, c) radiation spectrum peculiar for point 2, d) radiation spectrum peculiar for point 3

ence of iron, oxygen, silicon, chlorine and manganese atoms. The spot analysis of the chemical composition at another place also demonstrated the presence of the same elements. Iron and oxygen atoms prevail in the chemical composition of wear products. Such a result is the evidence of the penetration of oxygen in between the mating surfaces, which leads to surface oxidation and to the initiation of a phenomenon similar to corrosion. In the case of fretting wear, iron and oxygen atoms are the prevailing components of the wear products, too [1, 21, 29]. Thus, the thesis that the suspension system elements may be exposed to fretting confirmed in this case as well.

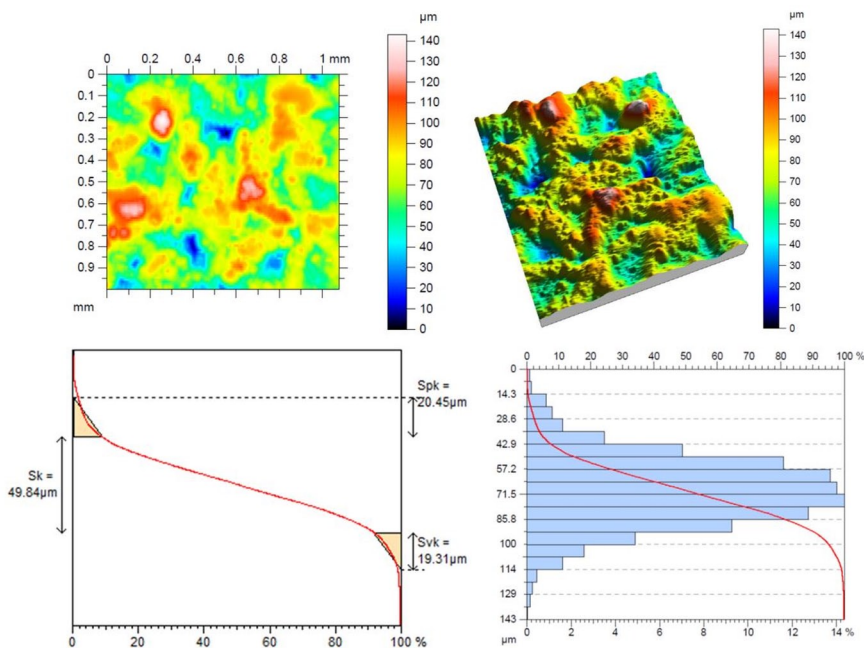
In the case the area affected by wear, it may be noticed that the maximum surface height  $S_z$  is  $143.2 \mu\text{m}$ , the arithmetic mean surface height  $S_a=15.04 \mu\text{m}$ , the maximum peak height  $S_p=69.68 \mu\text{m}$ , the maximum valley depth  $S_v=73.52 \mu\text{m}$  and the root mean square height  $S_q=18.93 \mu\text{m}$ .

All the height parameters even doubled in comparison with the surface not affected by corrosion. The quickly diminishing autocorrelation function ( $S_{al}=0.10691 \text{ mm}$ ) is peculiar to random structures.

The surface affected by corrosion has a random isotropic structure, as evidenced by the value of the texture aspect ratio  $S_{tr}=0.8574$  (the isotropy level 85.74%).

The local summit density decreased by the factor of two compared to the surface not affected by corrosion ( $S_{ds}=531.13 \text{ 1/mm}^2$ ). A large fractal dimension ( $S_{fd}=2.382$ ) was also obtained. The root mean square gradient was equal to  $S_{dq}=0.664$ , the arithmetic mean summit curvature reached  $S_{sc}=93.03 \text{ 1/mm}$  and the developed interfacial area ratio obtained  $S_{dr}=20.20\%$  doubled, confirming greater surface roughness.

In comparison to the surface not affected by corrosion, the area affected by wear is distinguished by a greater core fluid retention index

Fig. 10. The area affected by wear in profilometrical analysis

(Sci = 1.526) and diminishing valley fluid retention index (Svi = 0.1092) with the growing bearing index Sbi = 0.4821.
