## Analysis of the end-of-life the front suspension beam of a vehicle

Sławomir Kowalski<sup>a</sup>, Kazimierz Opoka<sup>a</sup>, Józef Ciuła<sup>a</sup>

<sup>a</sup>State University of Applied Sciences in Nowy Sącz, ul. Zamenhofska 1a, 33-300 Nowy Sącz, Poland

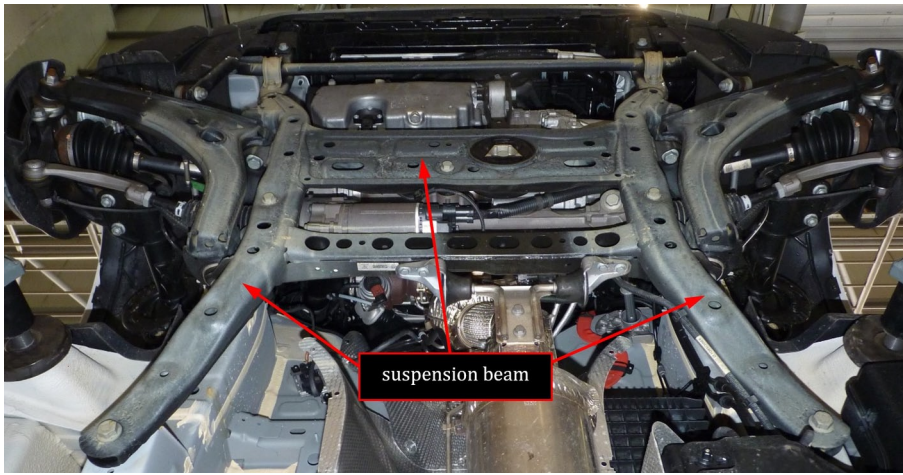
Fig. 2. View of the front suspension beam mounted in a delivery vehicle

The tested object was represented by a front suspension beam of a vehicle (Fig. 2). The beam is a component of suspension belonging to the group of independent suspension systems, which are distinguished by a separate system of guide elements permitting the independent wheel operation. In the case of that type of suspension, increasing the number of wheel guide elements and the related increase of the number of wheel movement planes enhances the option to ensure the appropriate transfer of forces to the vehicle body.

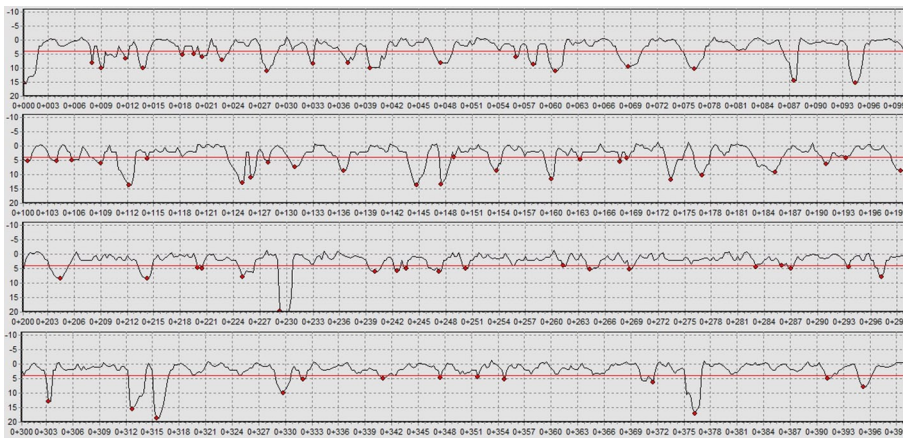
Fig. 3. Unevenness of road pavement in a form of a profile

Front suspension beams of five brand new delivery vehicles at the same distance in comparable conditions were inspected. The vehicles were used at various routes and roads and serviced both urban and rural areas. Fig. 3 shows the results of road pavement evenness tests for the selected road section, at which the vehicles were operated. The tests were conducted in accordance with BN-68/8931-04 with the use of the PD01 Omega planograph. The measurement was conducted at a 400-500 m section, and the planograph was set for the registration of maximum variances greater than 4 mm (the red line in the diagram). The pavement requires comprehensive heavy repairs or even redevelopment. The following defects: ruts, fissures, cracks,

reflection cracks, pavement chippings, potholes and roughness loss were noted.
